Governing Board Meeting

August 11, 2016

Ecological Conditions Update

Water Resources Division

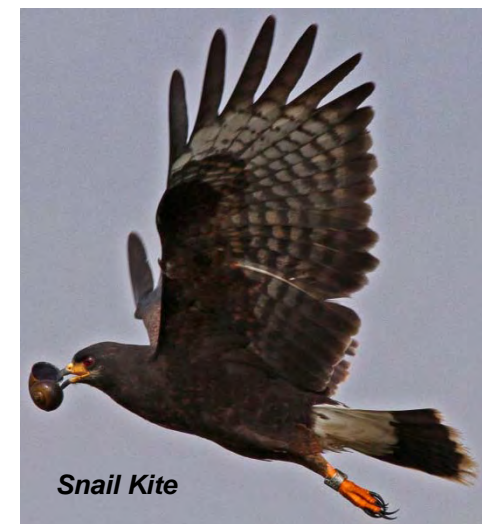
Lake Okeechobee Snail Kite Nests

- 170 nests in 2016 compared to 76 nests in 2015
- Includes 52 new late season nests (mostly in Moonshine Bay Treatment Area)
- 26 successful nests so far

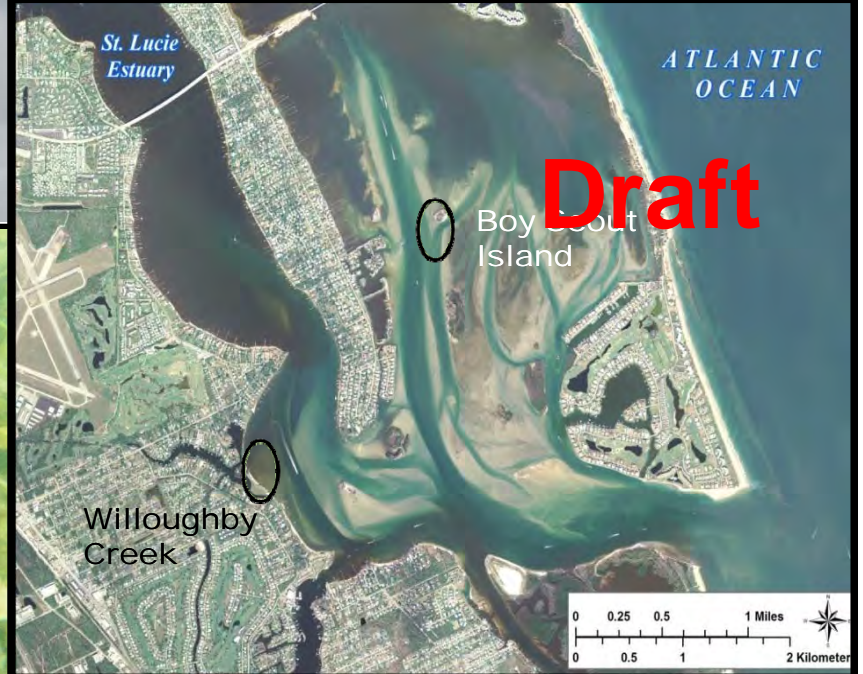
Boy Scout Island
Manatee grass

July 20, 2016

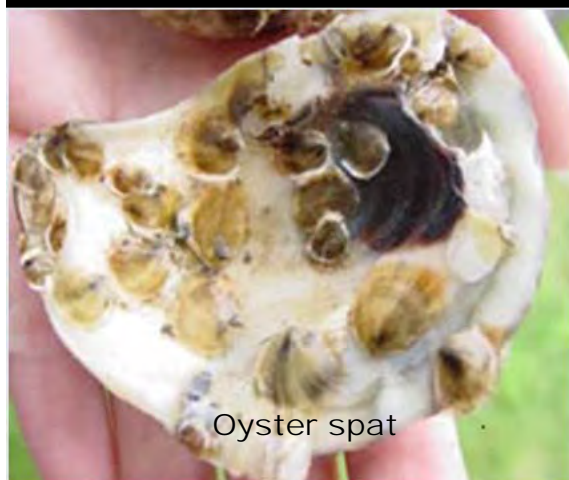
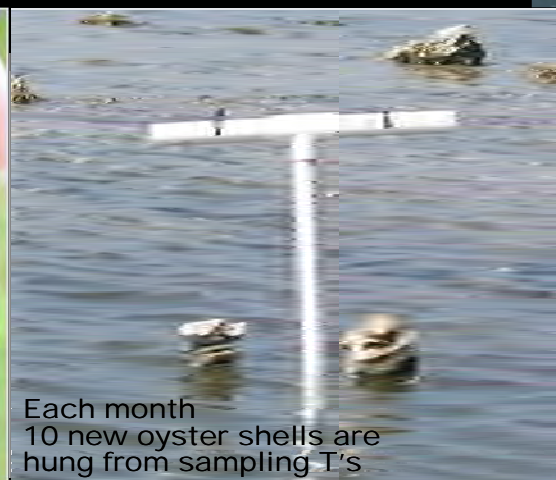
Caloosahatchee Estuary - Oysters

Seven day mean salinity of the water column at 3 monitoring stations in the Caloosahatchee Estuary

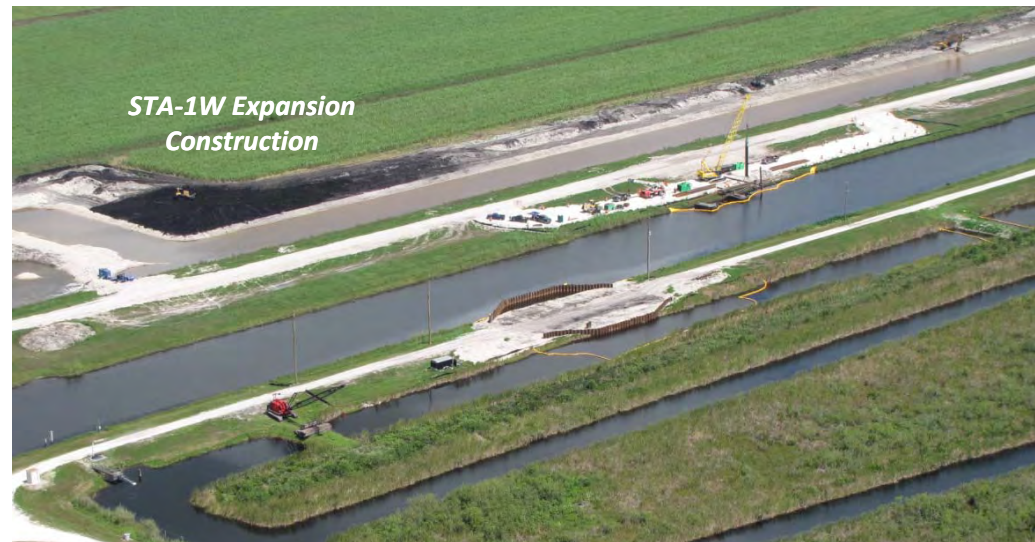
Stormwater Treatment Areas (STAs) Current Conditions

- Continued to send Lake releases south through A-1 FEB and STAs in July
 - Total Lake regulatory releases to FEBs/STAs in WY2017 (since May 1) ~56,000 ac-ft
- All treatment cells are at or above target depths
- Operation of existing STA-1W continues during STA-1W Expansion construction

Water Year 2017 (5/1/16 to 7/31/16)						
	STA-1E	STA-1W	STA-2	STA-3/4	STA-5/6	Total
Inflow TP (ppb)	155	171	95	28	148	89
Outflow TP (ppb)	24	28	19	13	25	19
Inflow Vol. (ac-ft)	49,133	22,385	88,053	121,586	29,034	310,191
